BUREAU OF SHIPS GROUP TECHNICAL INSPECTION REPORT

OPERATION CROSSROADS. U.S.S. INDEPENDENCE (CVL22)

TEST ABLE

VOLUME 1 OF 4 [U].

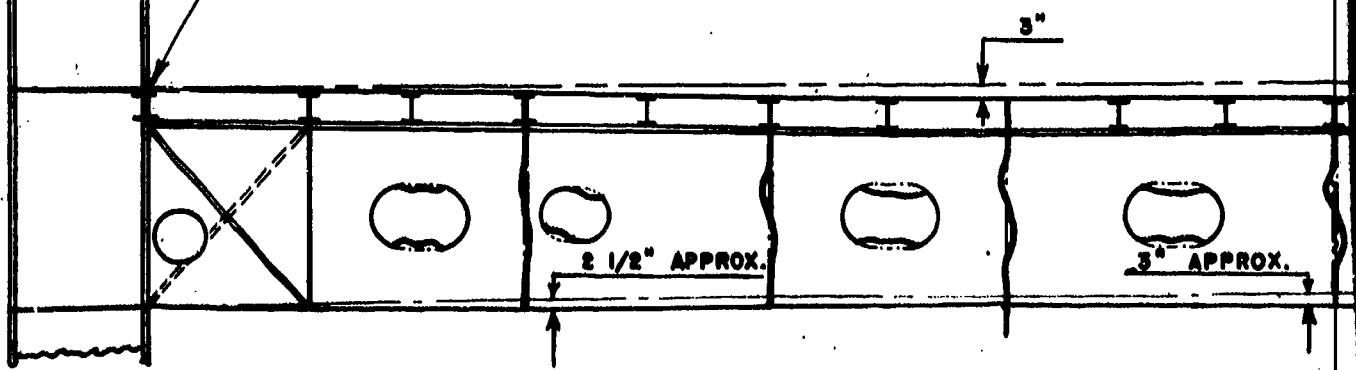
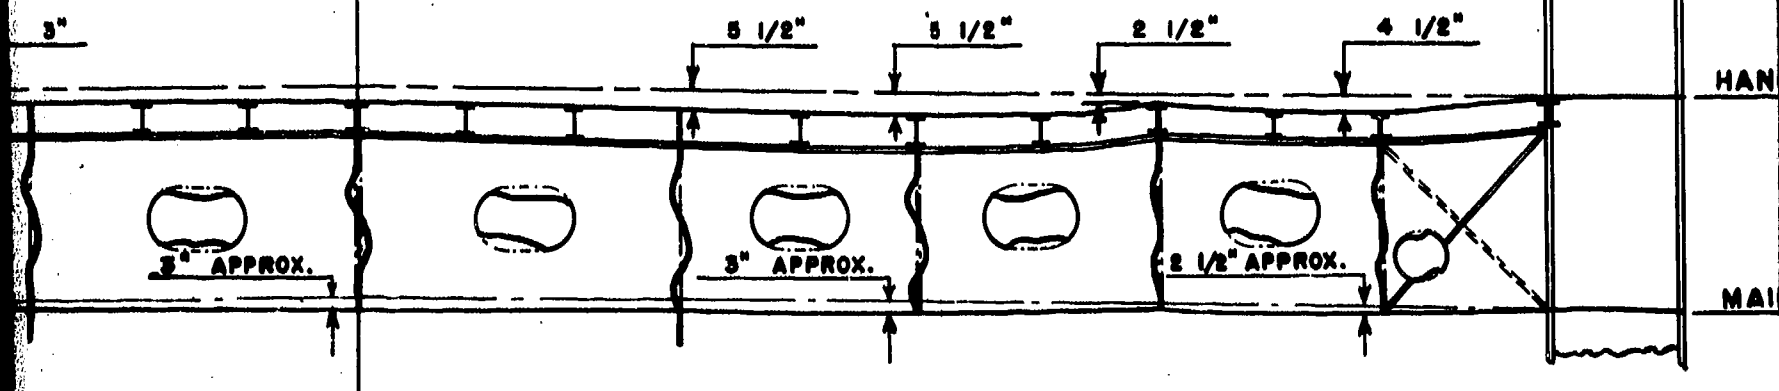
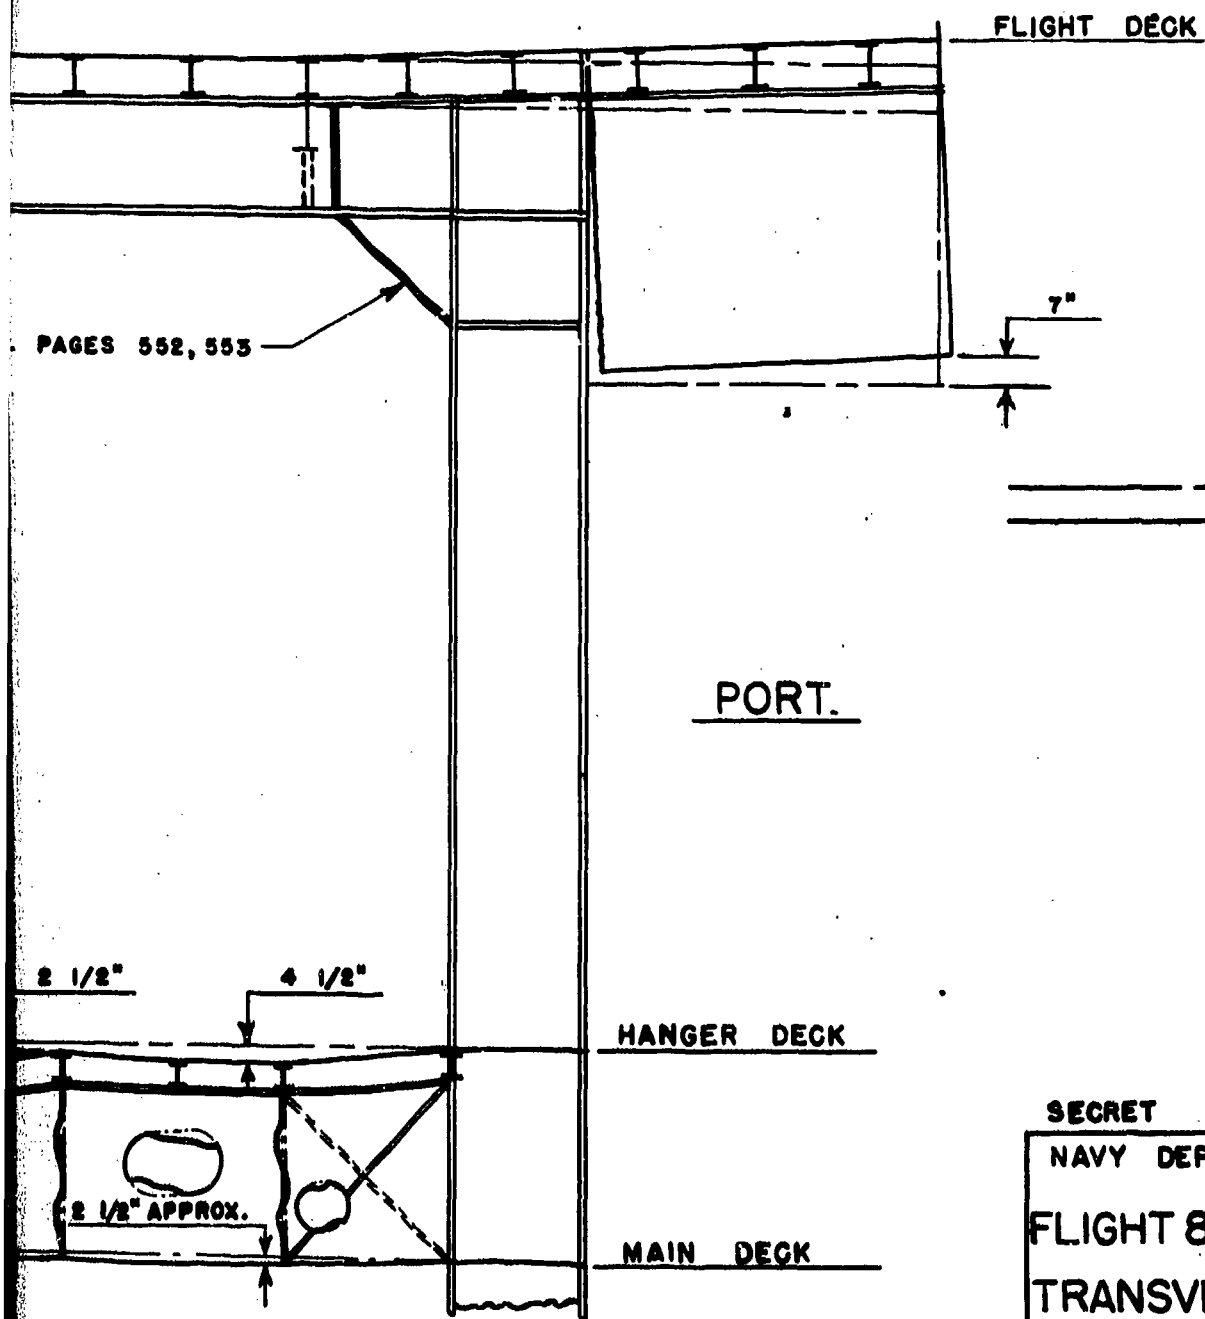
TRANSVERSE SECTION AT FR.115
LOOKING AFT

PHOTO. PAGE 555

PHOTO. PAGES 552, 553

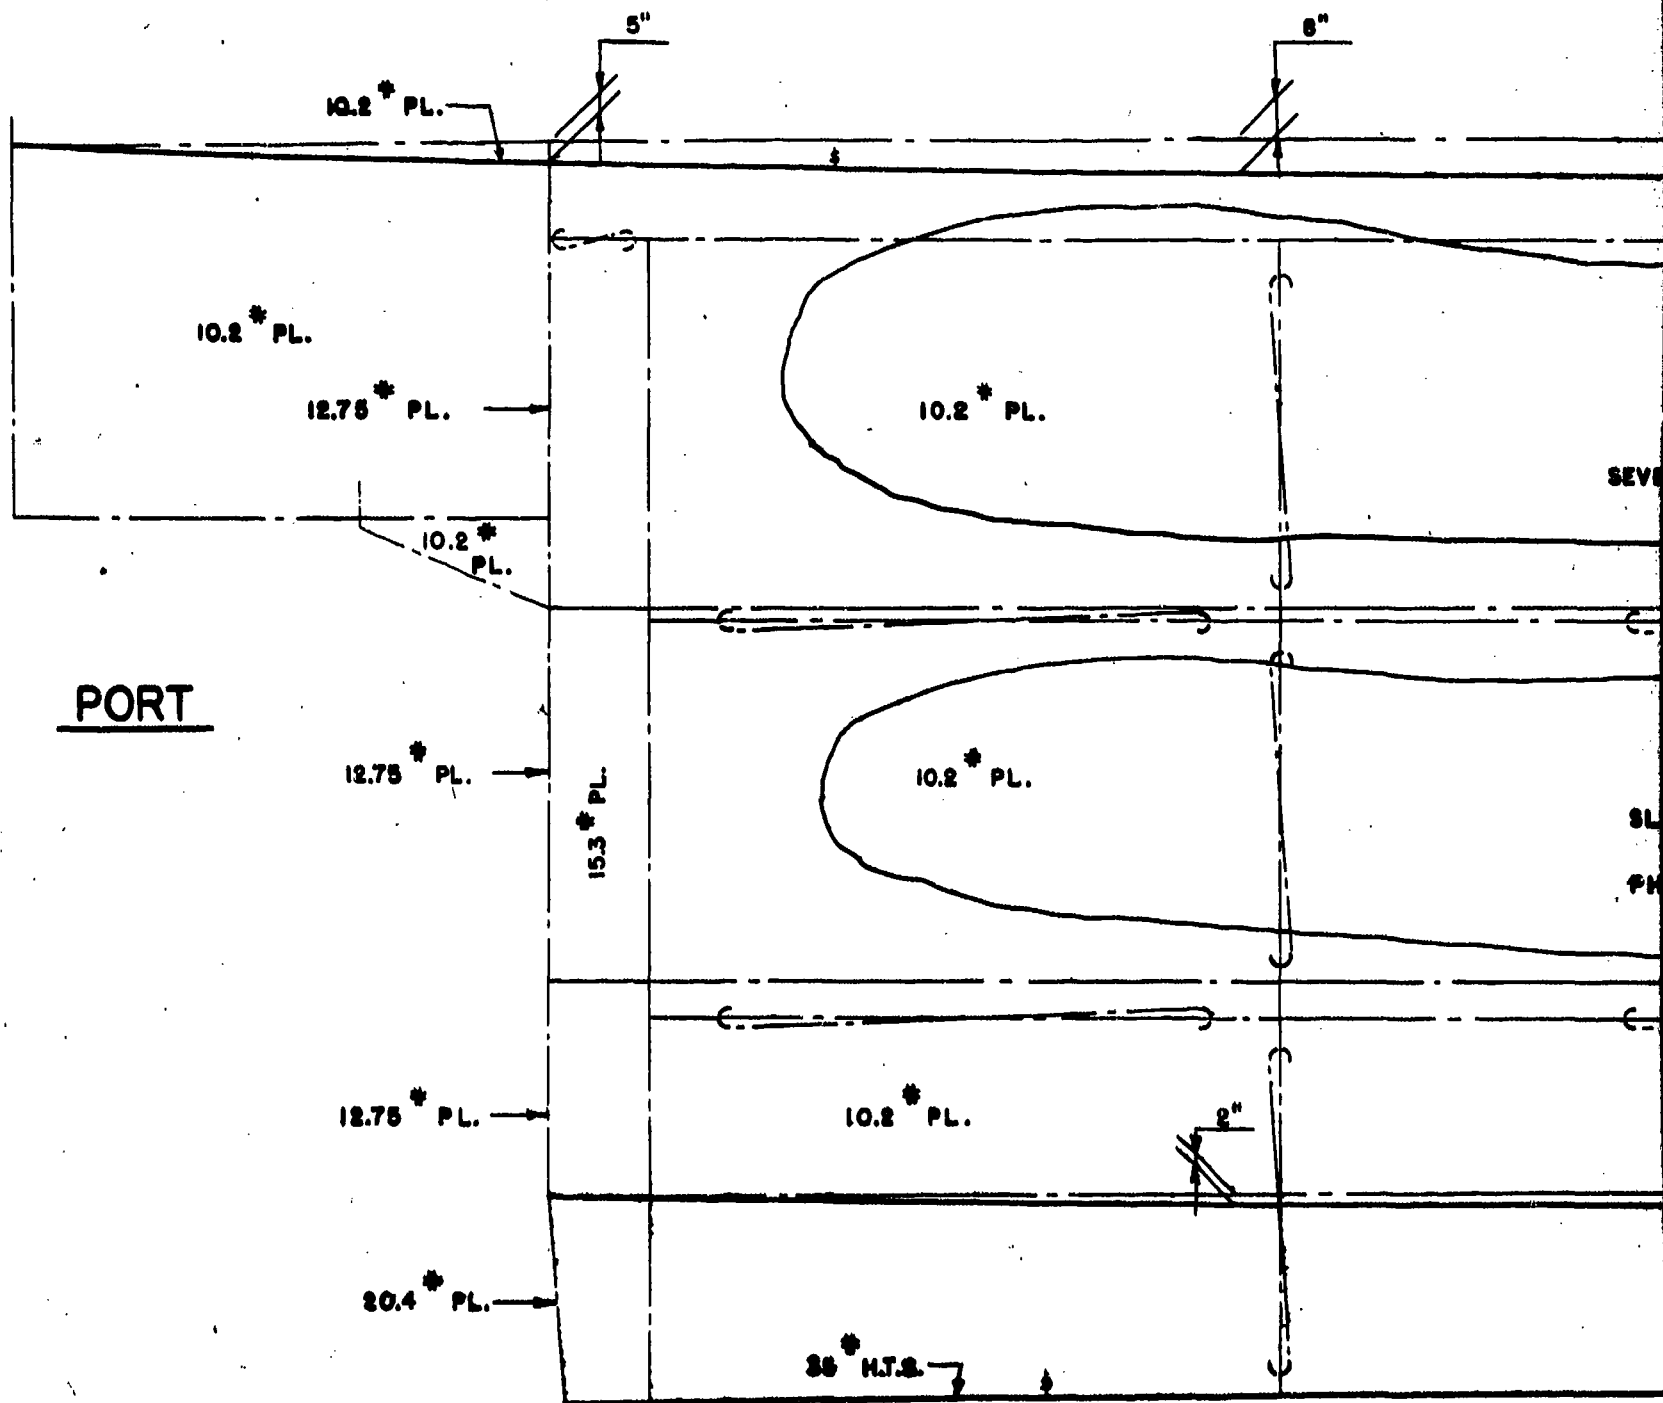
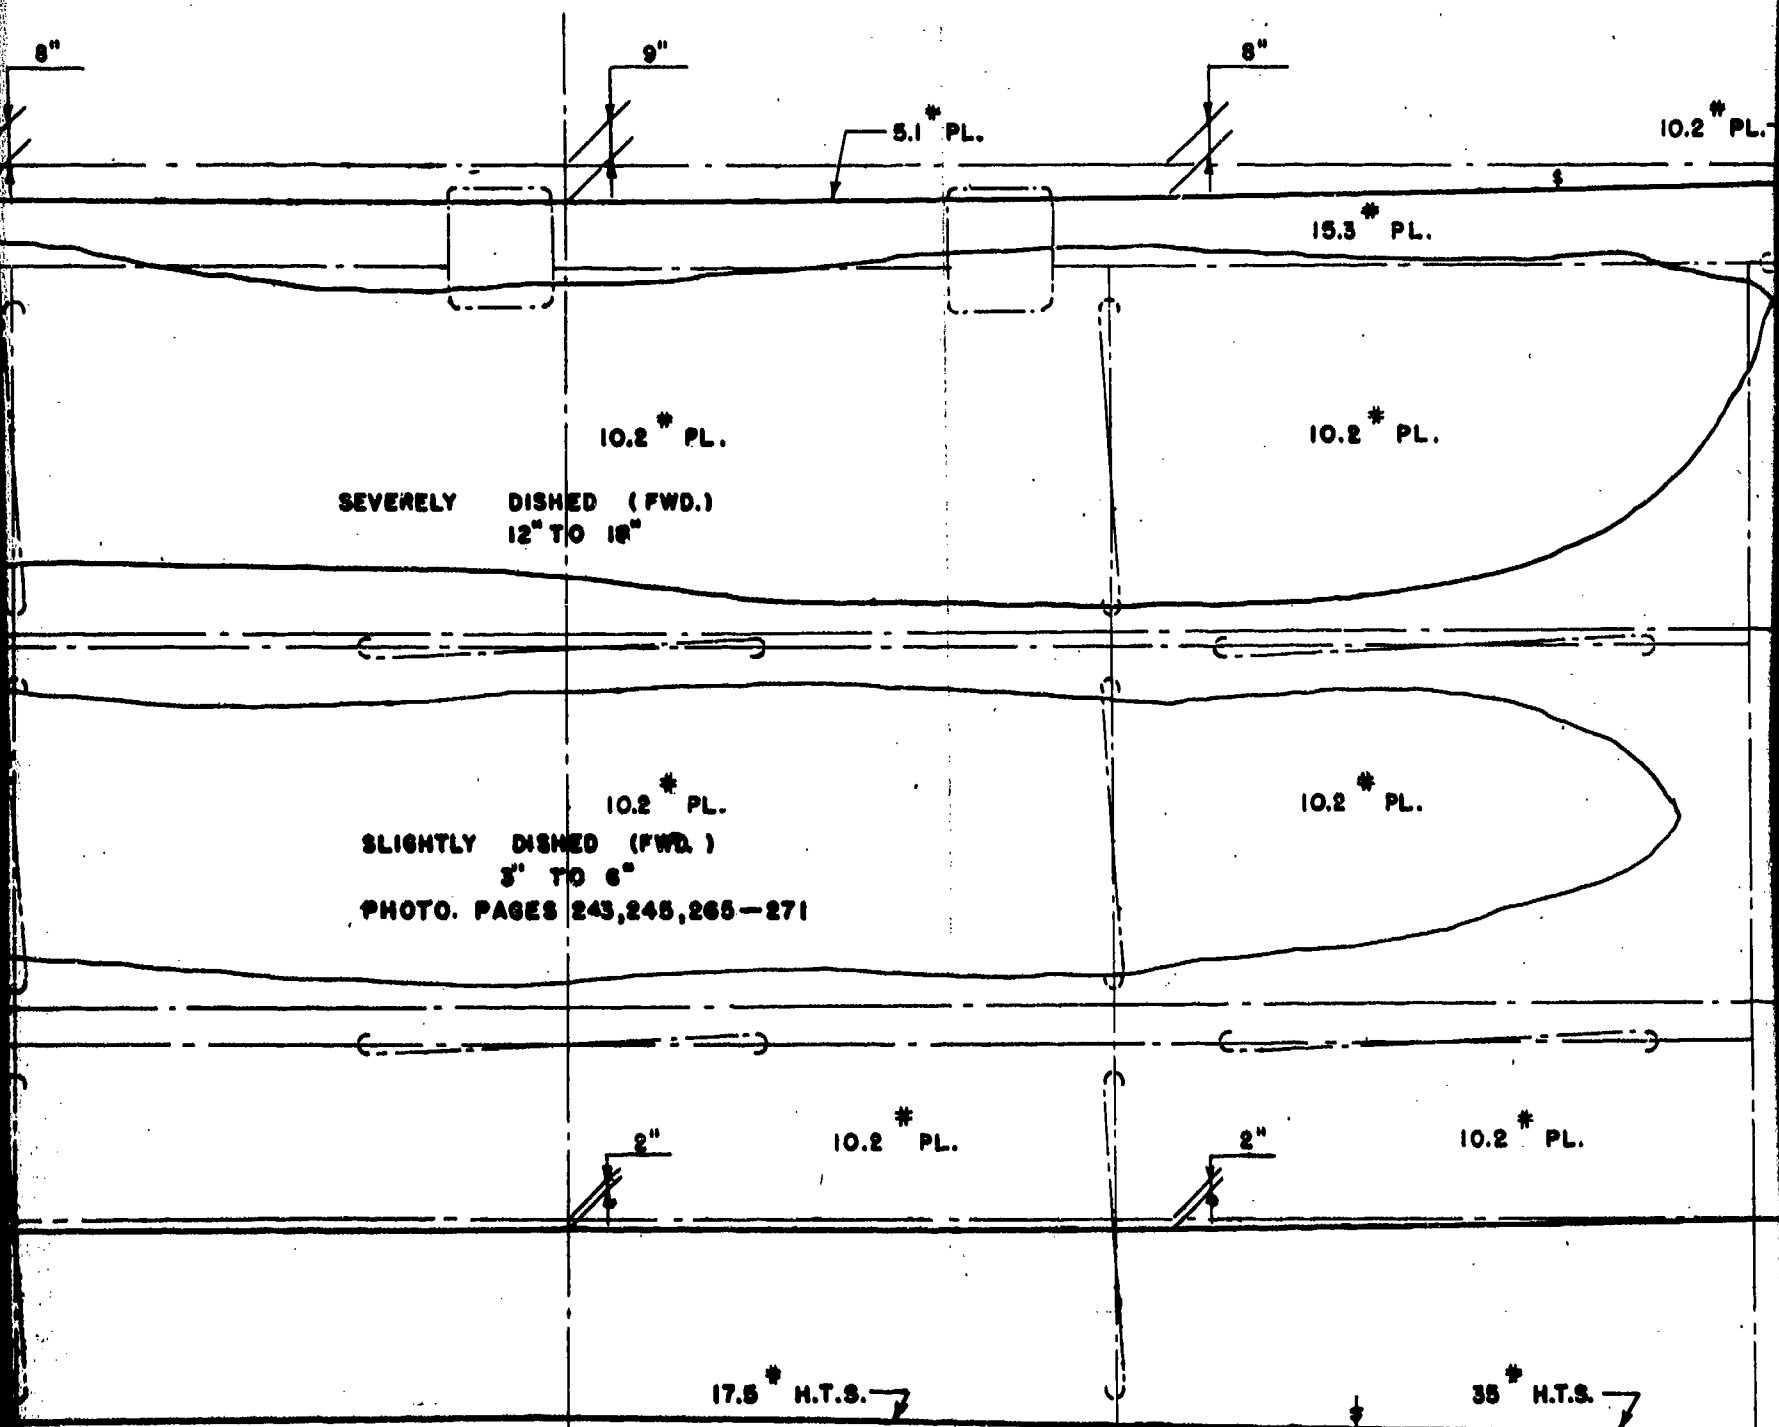
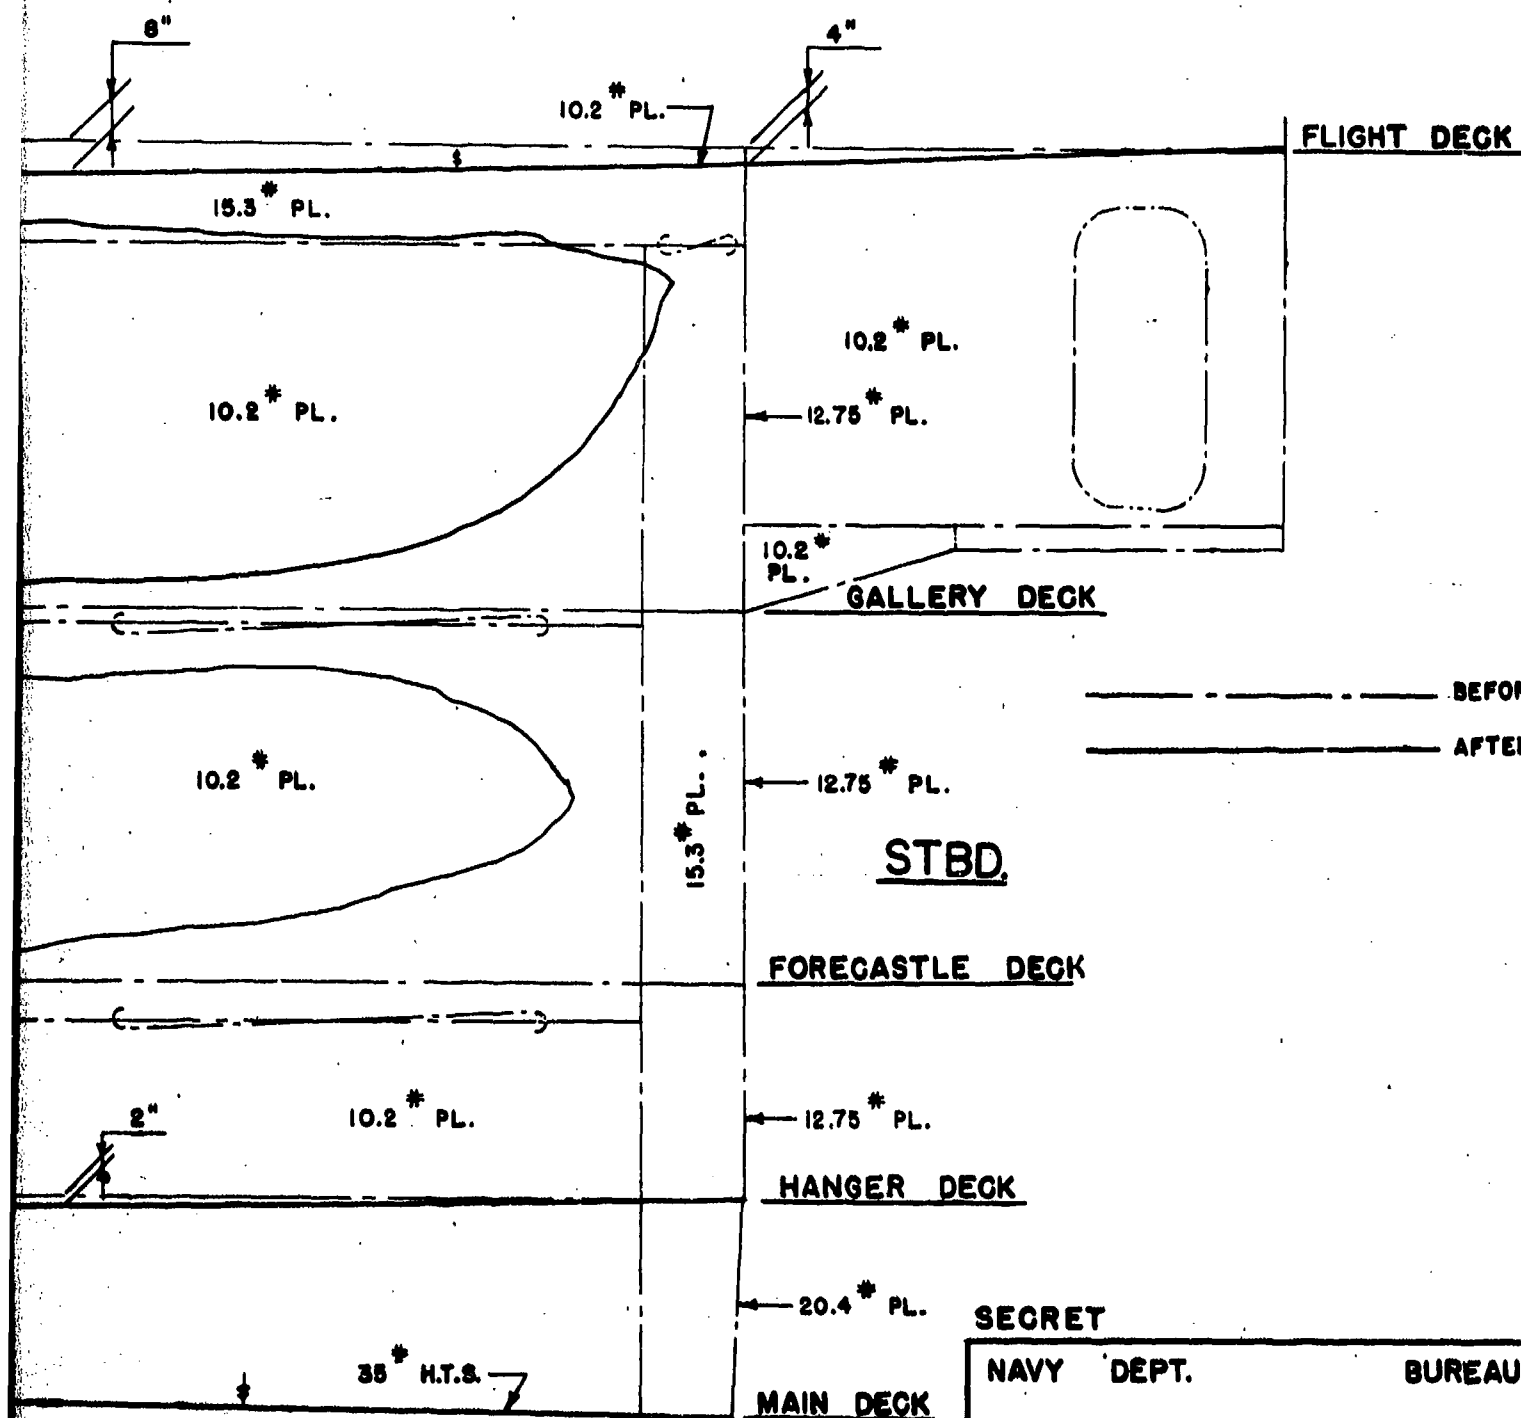
PLATE NO. 28

TRANSV. W.T. BHD. 45
LOOKING FORD.

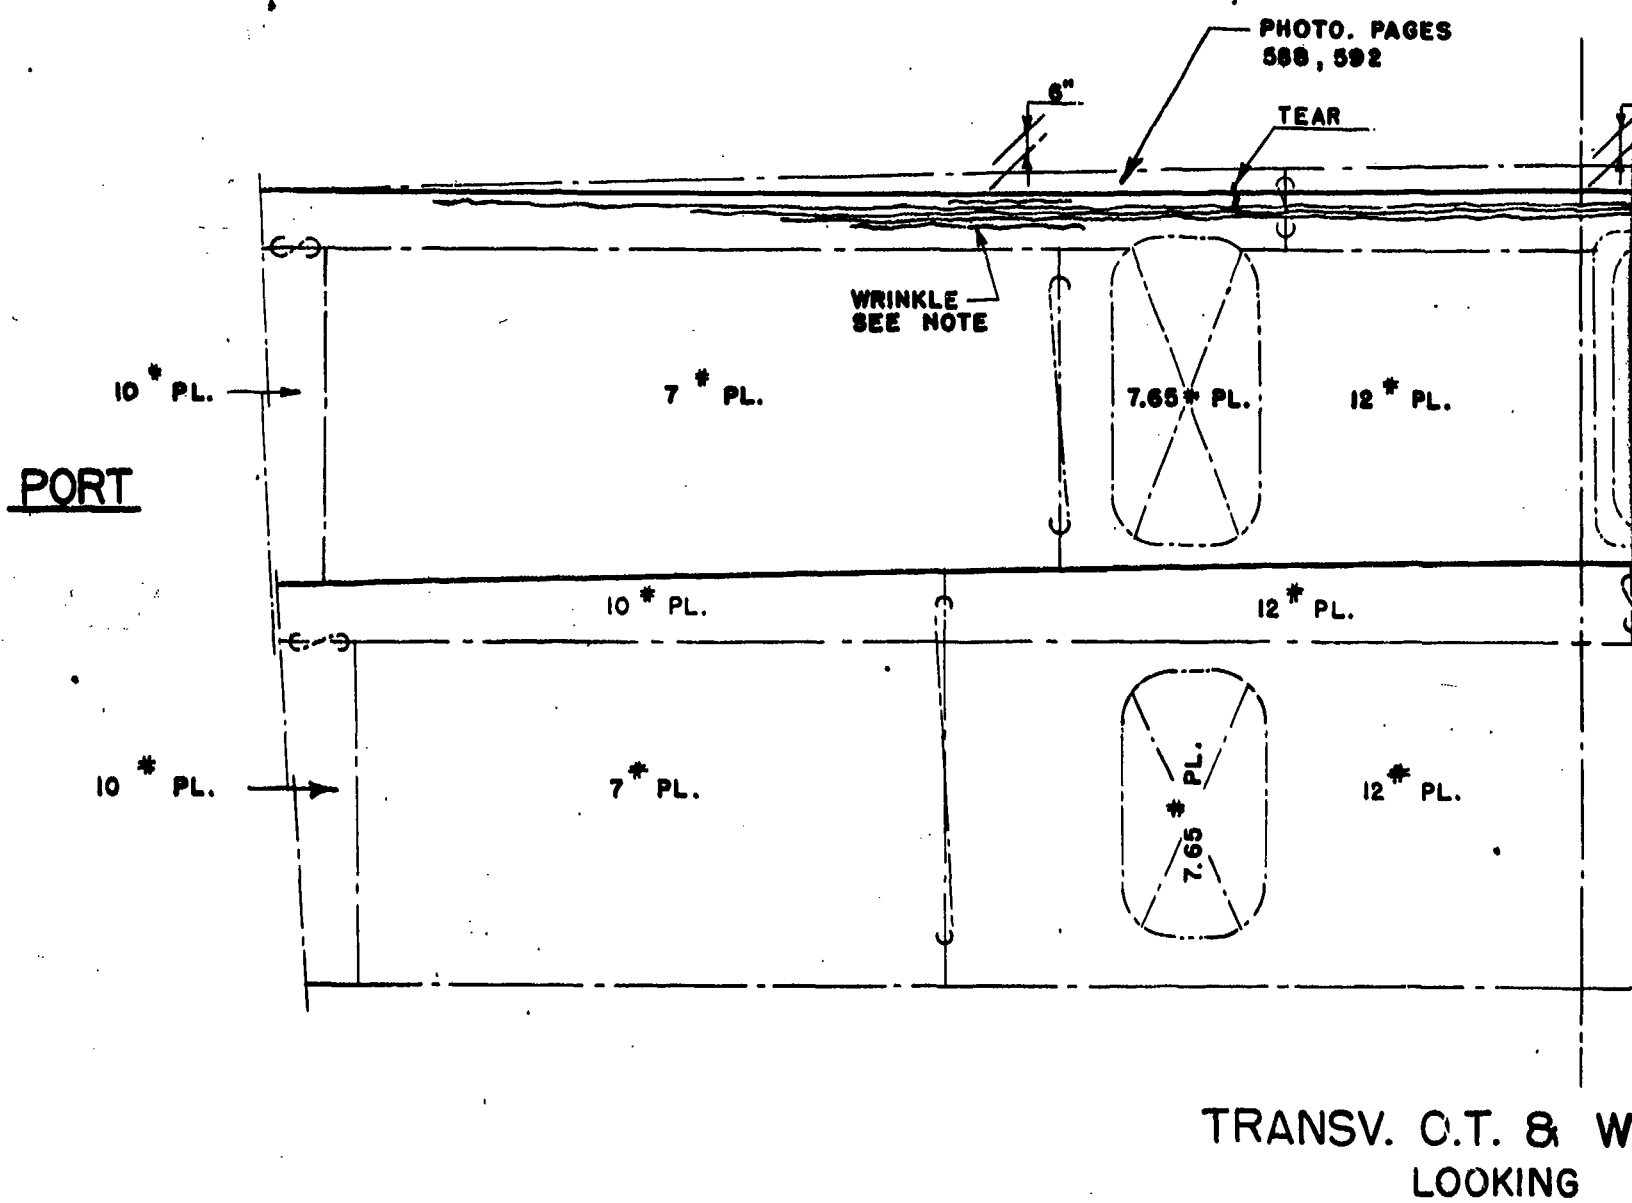
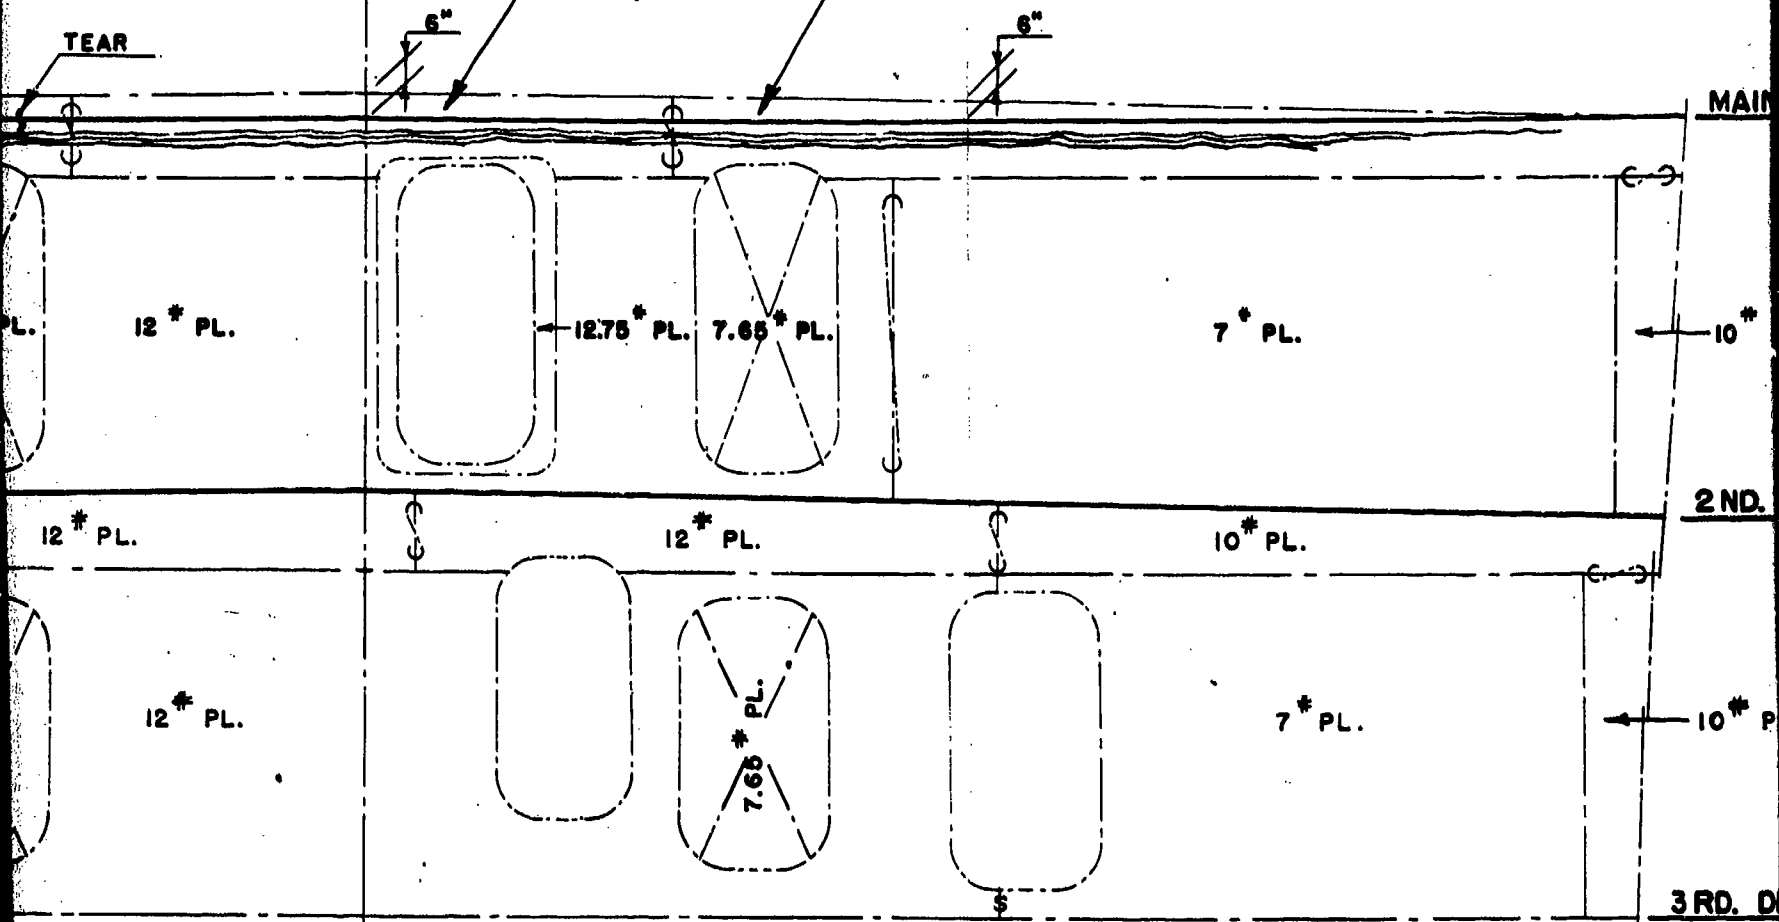
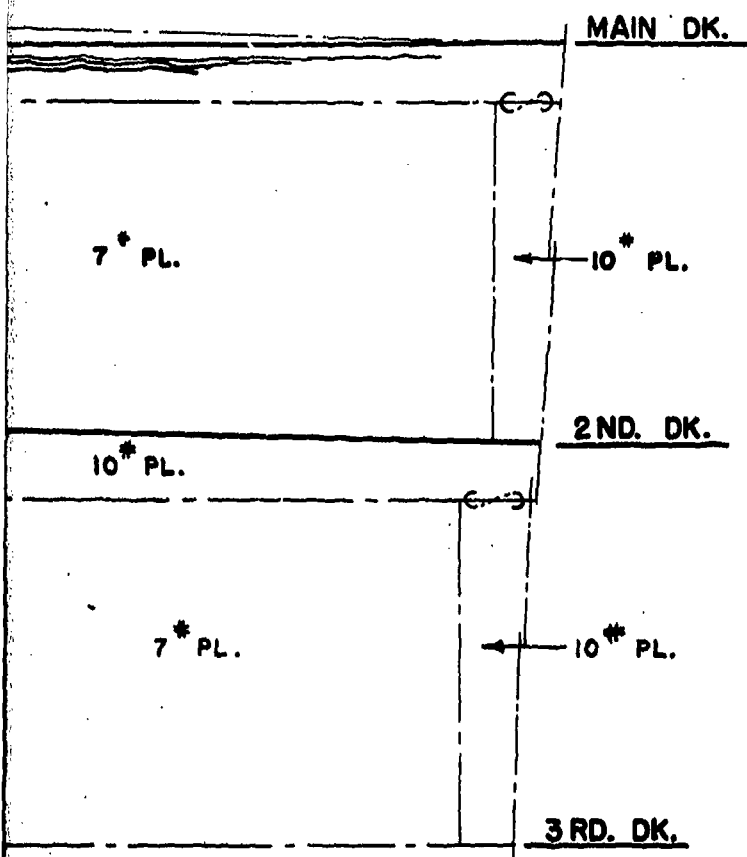
PLATE NO. 29

RANSV. O.T. & W.T. BHD. 49
LOOKING FORD.

NOTE:
NO. OF LINES INDICATE DEPTH
OF WRINKLE IN PLATING (INCHES).

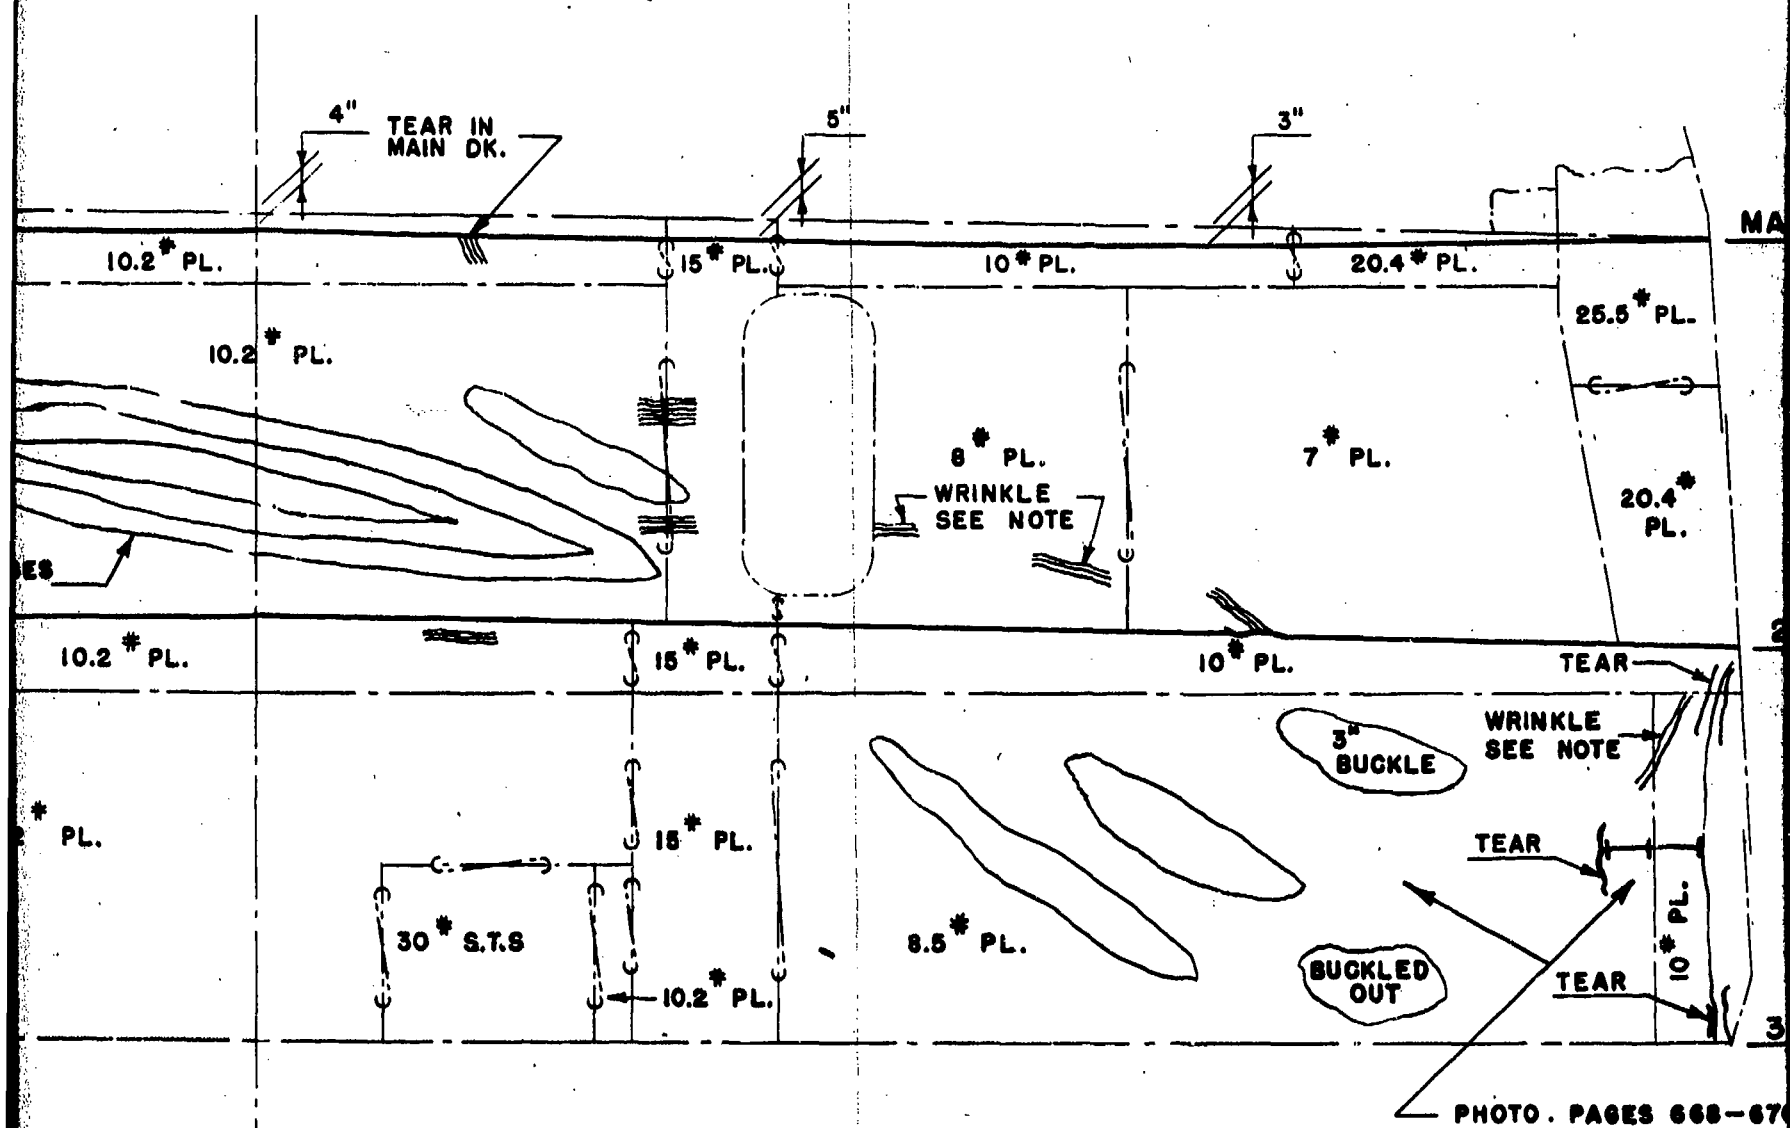
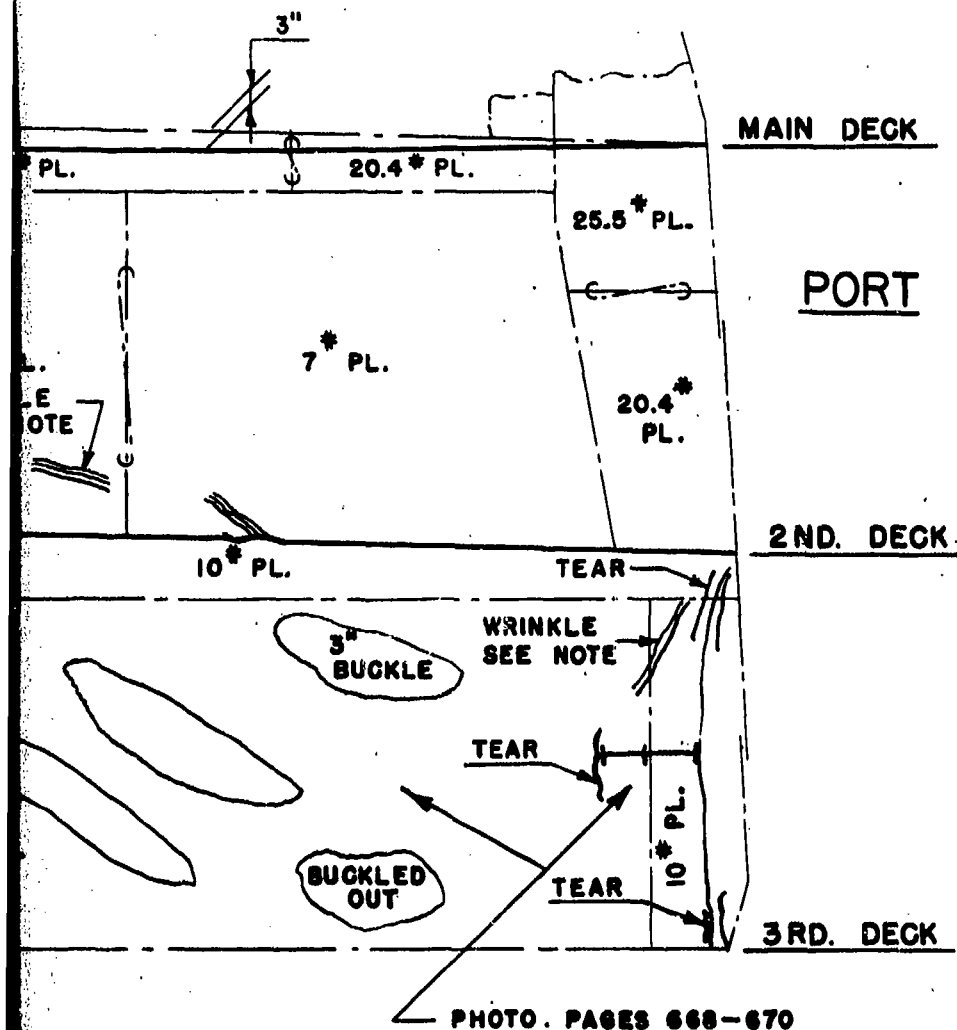
V. OT. & W.T. BHD. 113
LOOKING AFT.

NOTE:
NO. OF LINES INDICATE DEPTH
OF WRINKLE IN PLATING (INCHES).

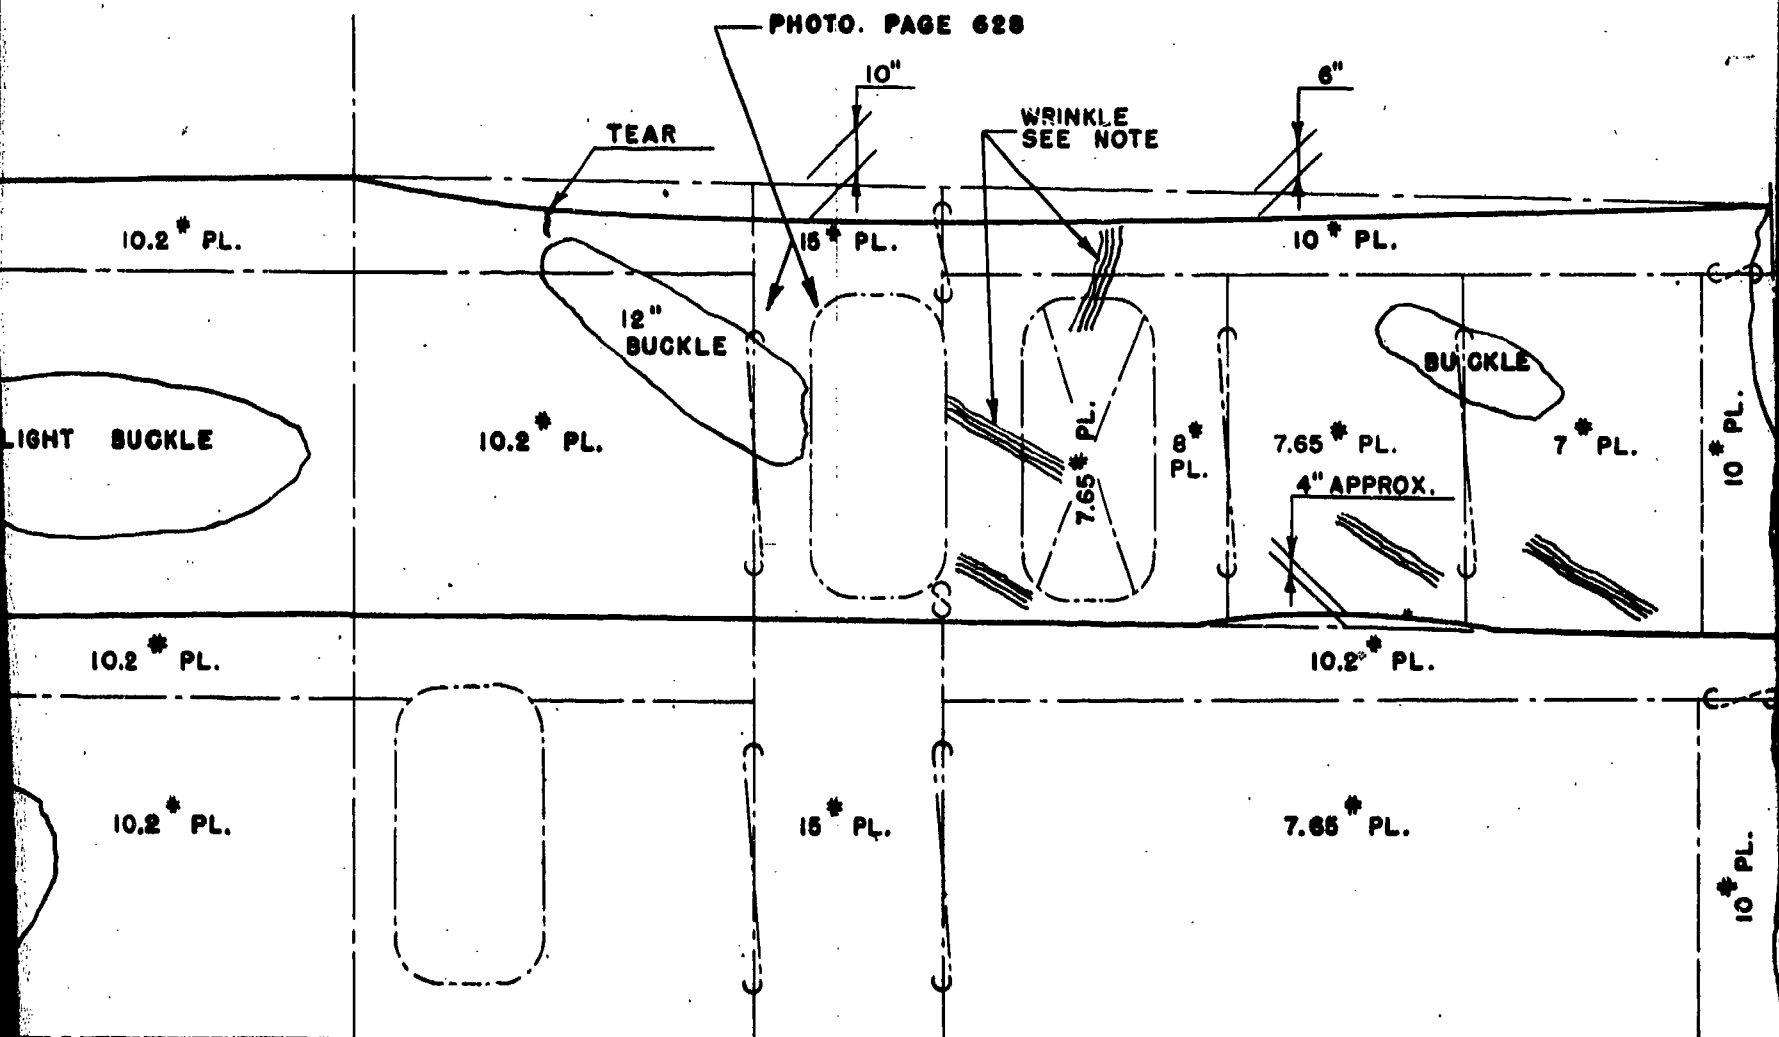
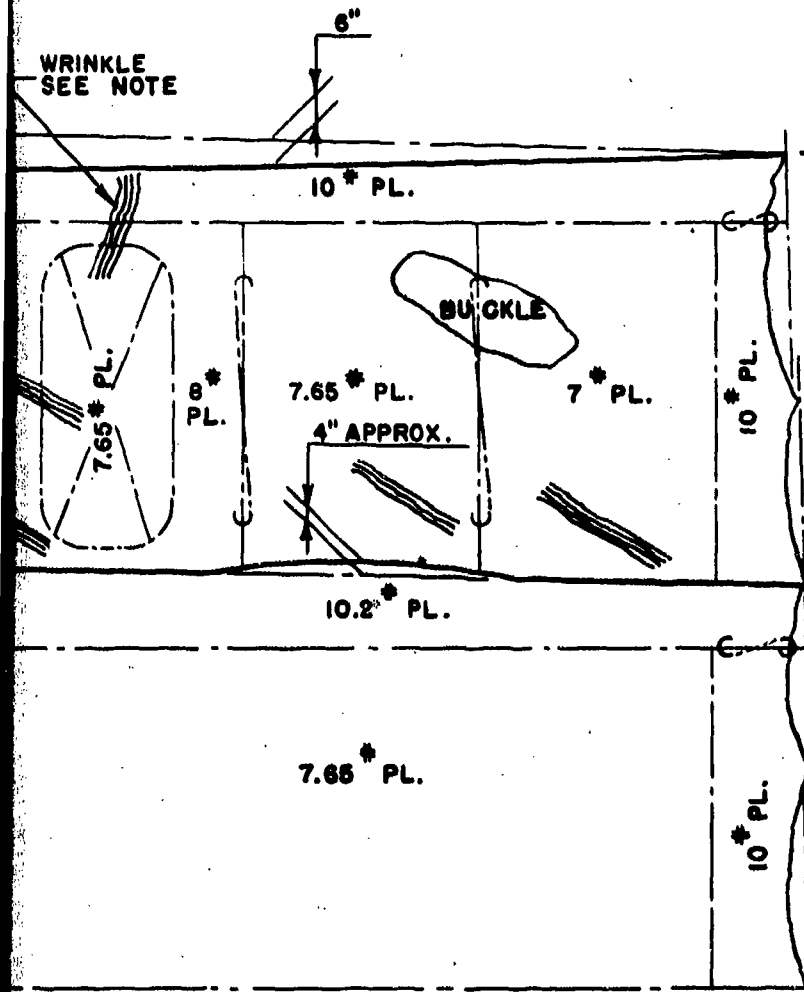
TRANSV. O.T. & W.T. BHD. 119
LOOKING AFT

SECRET
NAVY DEPT. BUREAU OF SHIPS
MAIN & 2ND. DECK DEFLECTION
TRANSVERSE BULKHEAD FR 119
TEST A
U.S.S. INDEPENDENCE CVL 22

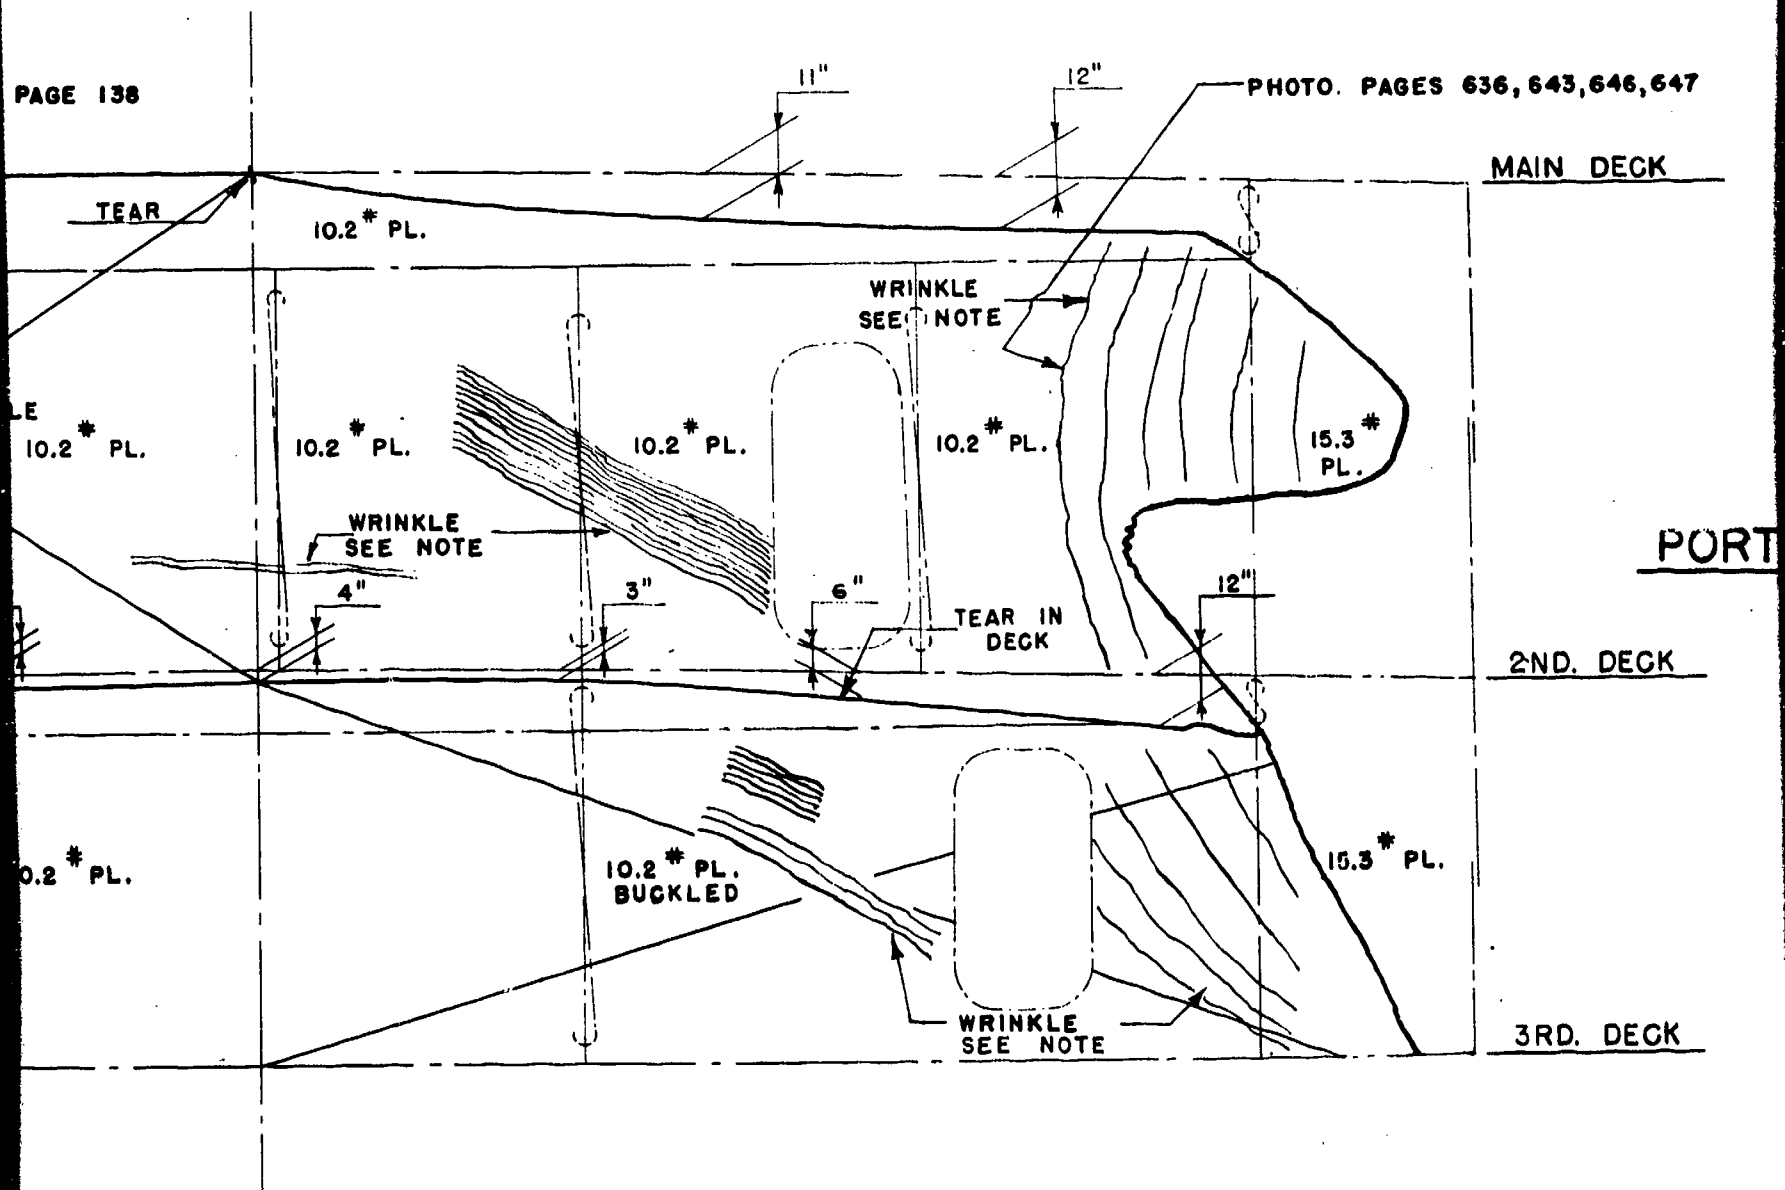
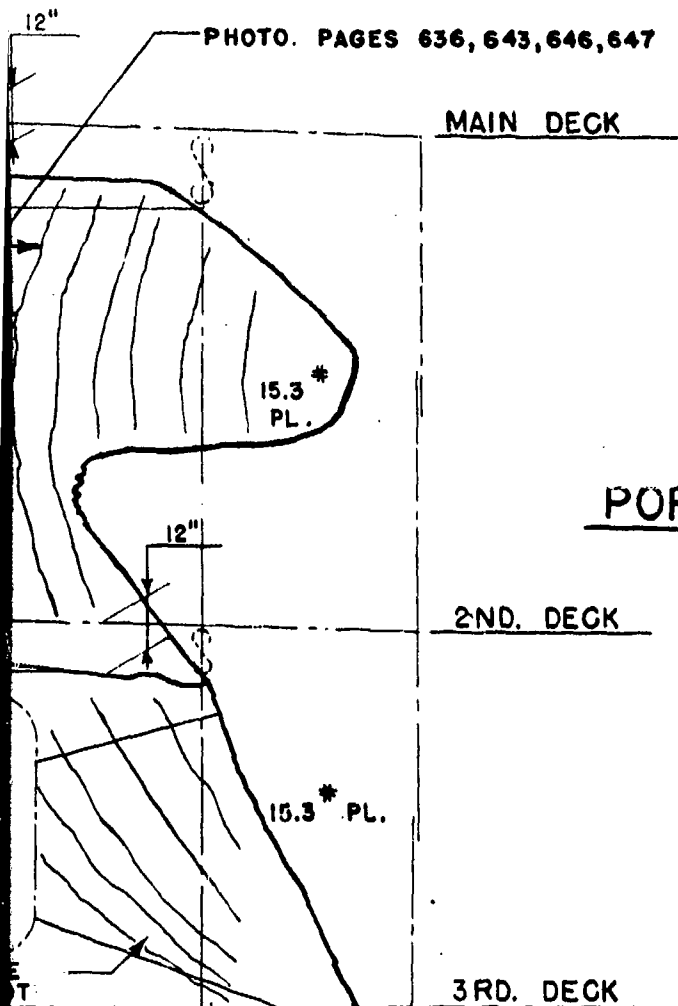
TRANSV. BHD. 138
LOOKING AFT.

NOTE:
NO. OF LINES INDICATES DEPTH
OF WRINKLE IN PLATING (INCHES).
